3.0 Site Description and Inventory

3.1 Analysis of Existing Natural Resources

3.2 Analysis of Existing Built Resources

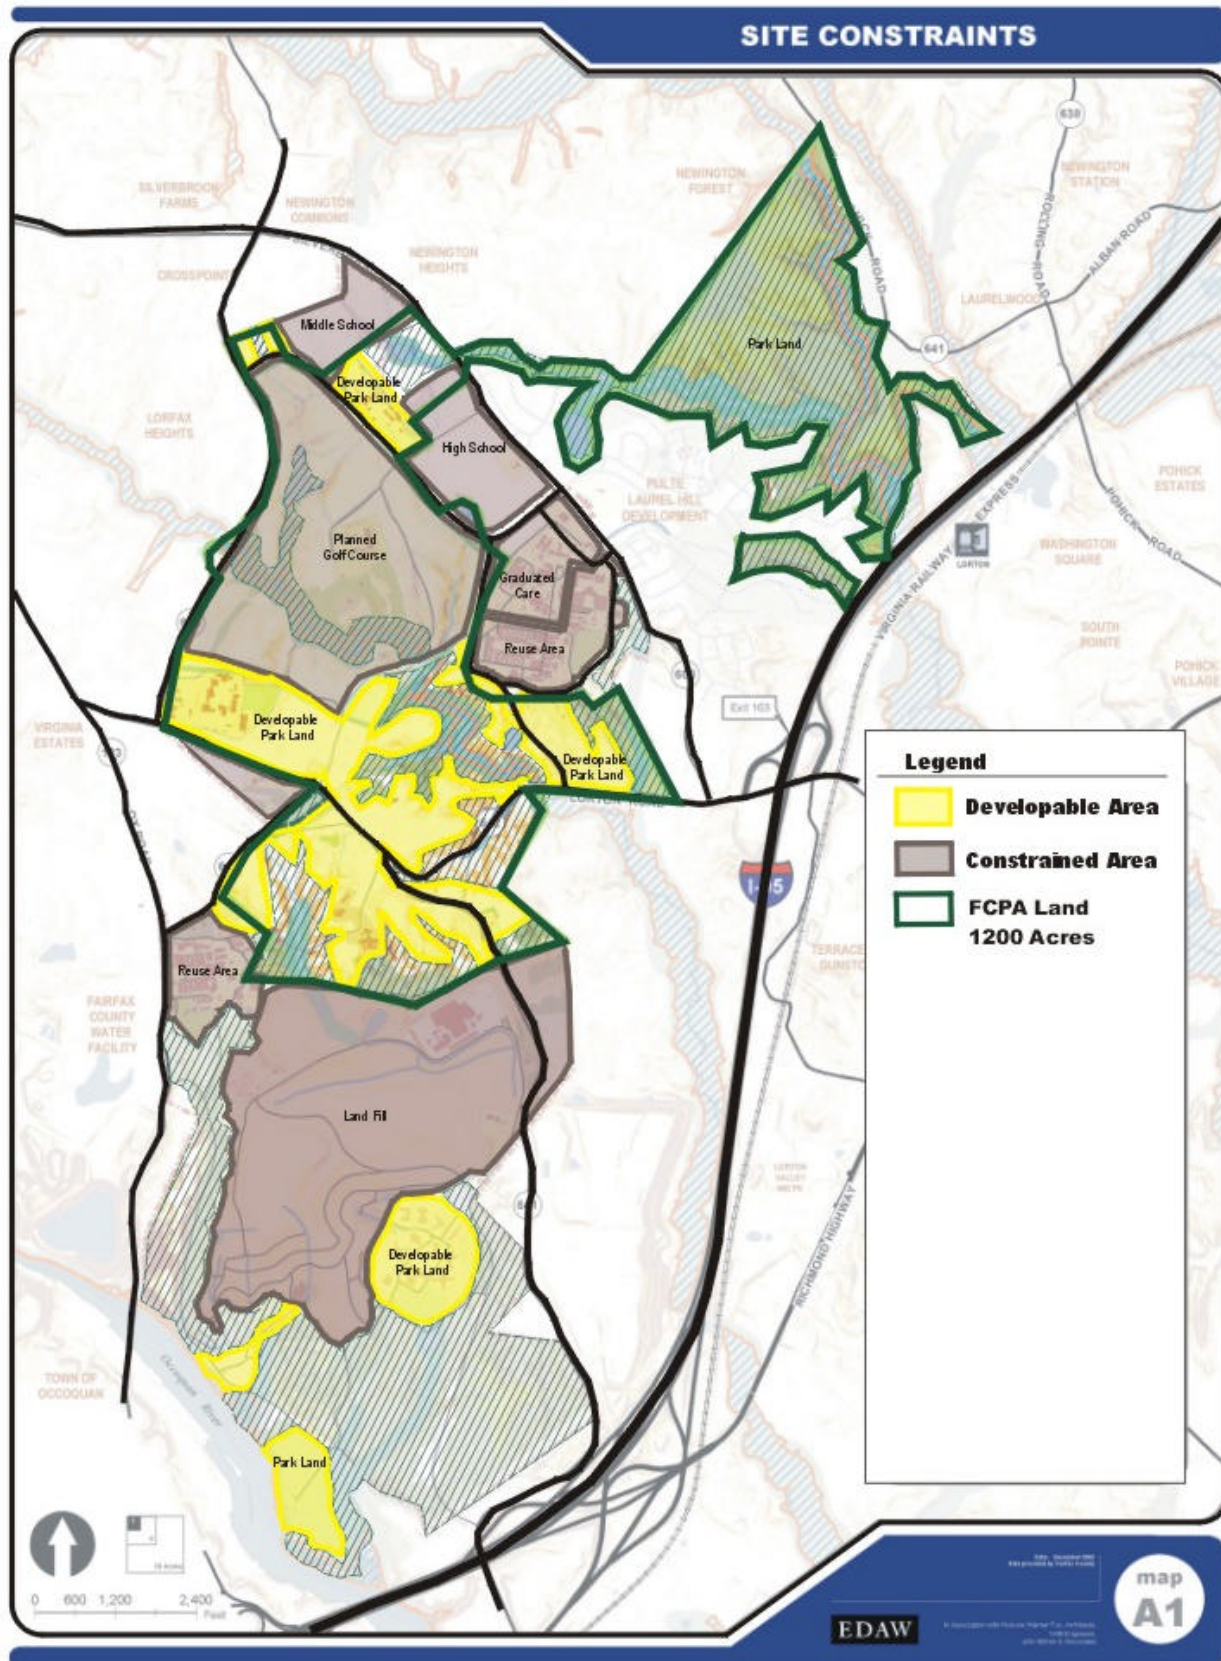
Figure 14: Summary of Opportunities and Constraints

When these areas are combined they account for approximately 880 acres of the remaining 1,310 acres which leaves approximately 430 acres of land that can be developed for active recreation uses. **See Figure 14.**
